Water renovation

Kynastteich, Berlin, Germany

1 Park ring pond 3000 m³ with
OLOID Type 400

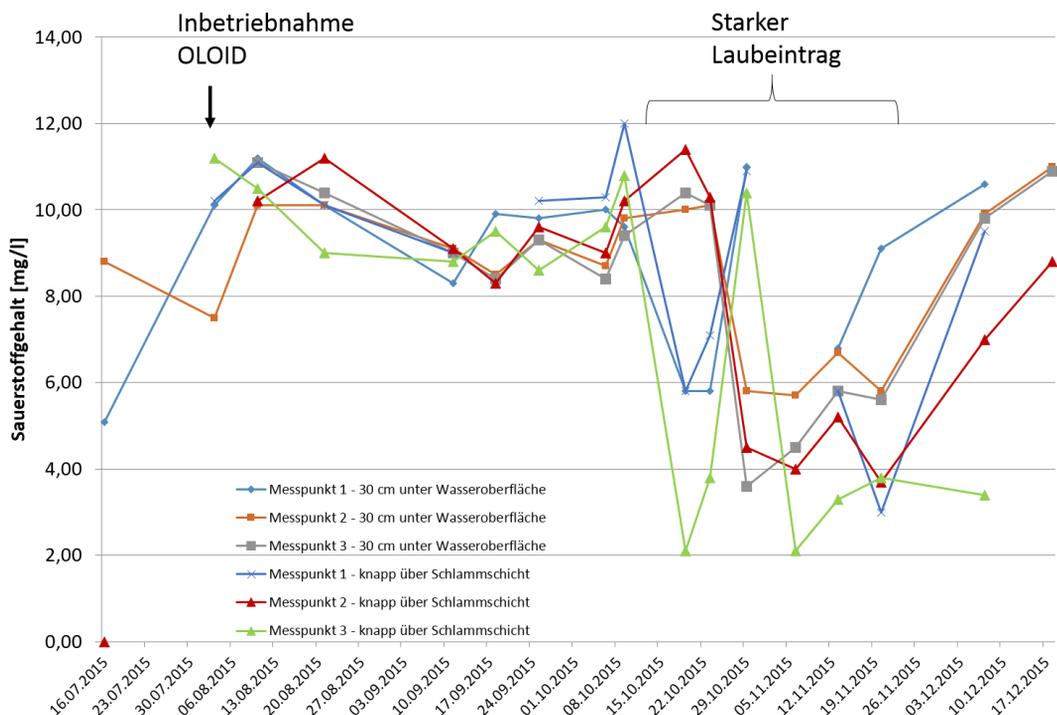
The oxygen measurements show that with initiation of the OLOID, oxygenation takes place. The oxygen content tends to decrease with depth which is typical for standing waters. Here it can be seen that the OLOID initiated oxygenation. Until the middle / end of October 2015 it can be seen that a good to very good saturation is documented of oxygen in water. The end of October / November 2015 lower oxygen levels were measured, this is likely to be linked to the death of aquatic plants and the high foliage entry and thereby initiated ablation process. Mid-December 2015 were again higher oxygen contents and a nearly oxygen saturation measured. Reasons for this are in addition to the operation of the OLOID also in the temperature dependence of both the solubility of oxygen in the water and the microorganisms activity on the other.

Before OLOID installation an additional water entry between 05/20/2015 and 07/15/2015 of approximately 1.176m³ was done to raise the water level. On 08/03/2015 an OLOID Type 400 was installed. During a 4-month period (until week 50) weekly visual water inspection and oxygen measurements were carried out (results are in the graph on page 3).
